VISIT ITINERARY

Early Christian church in Harilaq

Early Christian church in Kasterc

Early Christian church in Korisha

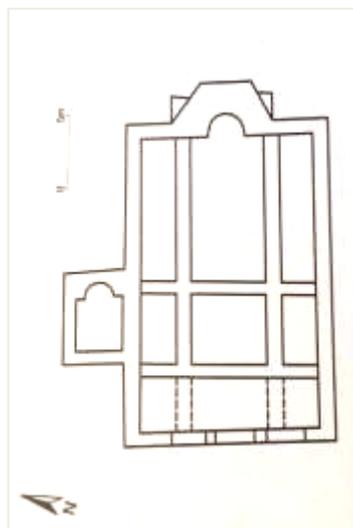
Figure 1. Plan of the basilica(F.Peja, B.Rraci, A. Hajdari-The castle of Harilaq,2015)

The three aisled basilica with an orientation from east to west has dimensions 22.2x 13.5m with an apse that is rectangular in the interior and angled in the exterior. The walls of the structure are 1m thick, while in the part of the apse the thickness goes up to 1.5m. The central nave of the naos is 11.50m long and 4.85

wide while the side aisle are 9.50 long and 2.25m wide. The narthex of the basilica is 3.30 long and the exonarthex 4.10m. The communication from the narthex to the naos was possible through three entrances separated with pillars, a typical early Christian *tribelon*. A small chapel was attached to the northern part of the basilica, with dimensions 5.80x3.90m and has an apse wide 1.90m. This chapel had only an opening from the side aisle of the basilica. The walls of the church are constructed of stonemasonry with lime stone bonding. Only the wall by the apse is built with bricks on the inside and stones on the outside. According to C. Haluk, this is a typical arrangement of the Constantinian period, but timewise it fits with later examples which became typical of Early churches of Constantinople⁴. (Çetinkaya 2017)

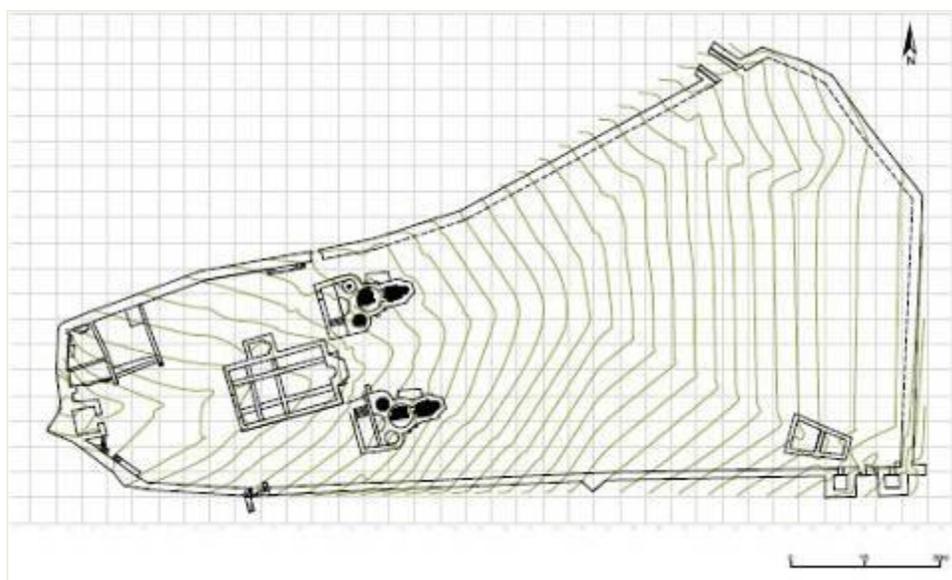
Figure 2. Plan of Harilaq fortress (F.Peja, B. Rraci, A. Hajdari: Castle of Harilaq, 2012)

The early Christian church in Halilaq lies inside the the castle of Harilaq, a castle that has the characteristic of the castles of the Justinian period. This stronghold enters in the group of castles and fortifications reconstructed and constructed in Dardania (61 reconstructed and 8 constructed), by the byzantine emperor of Dardanian origin Justinian the Great (527–565 AD), recorded in the written work by the byzantine

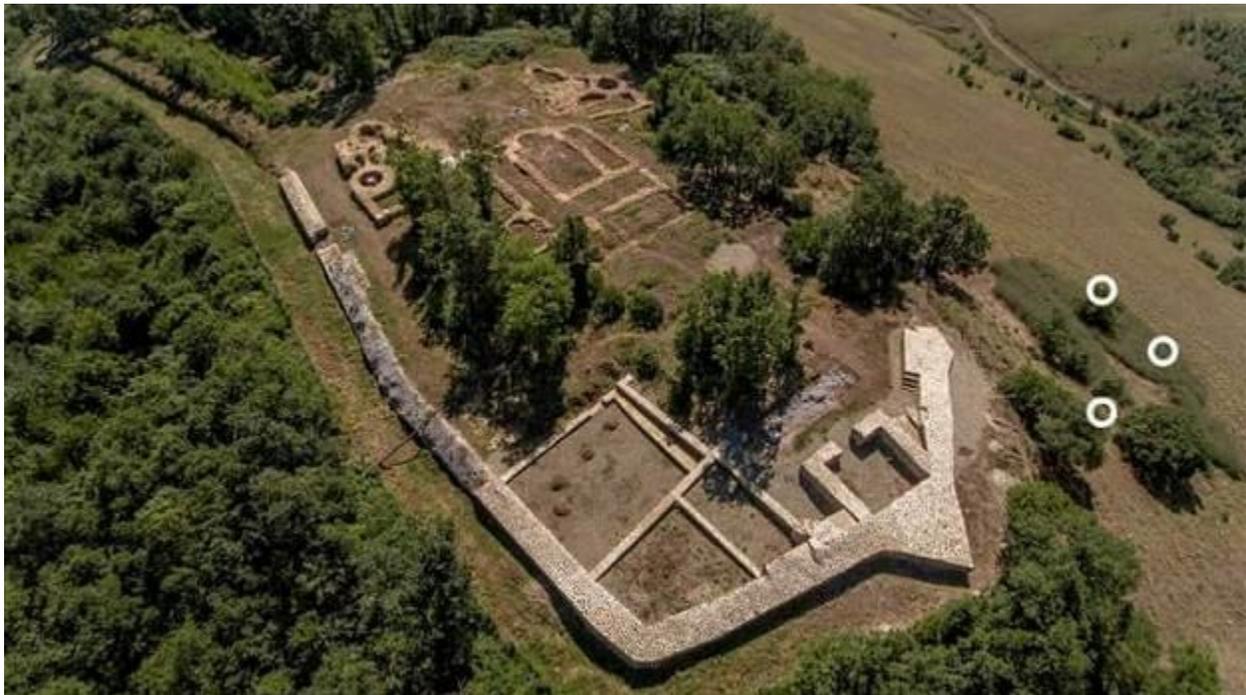
Figure 3. Drone view over the Harilaq castle. (voyagekosovo,2018)

The so-called fortress church is located on a slightly elevated ground, on natural rock, with a view over the whole castle. The architecture of the church was adapted to the terrain of the natural rock, with the central nave being slightly higher than the side aisles.

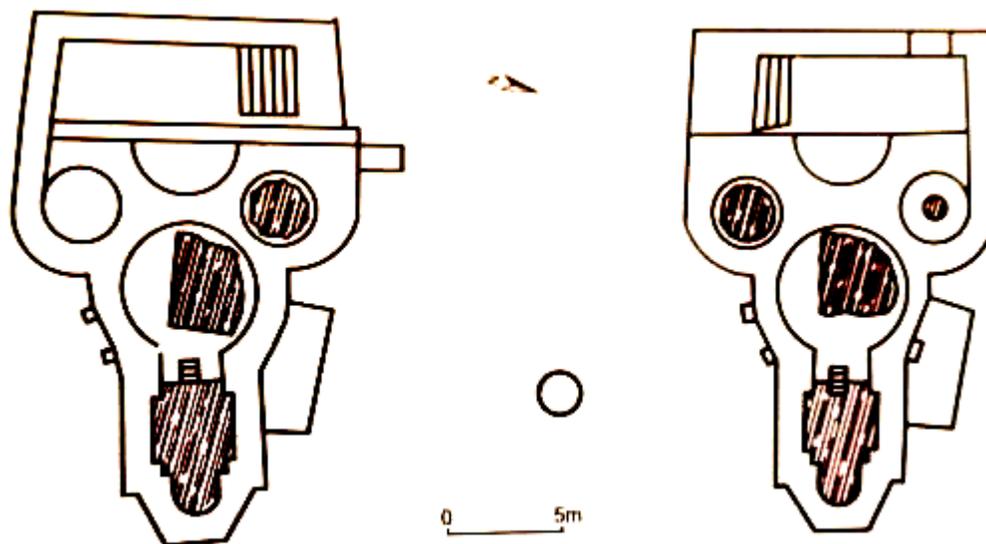
Figure 4. Plan of "ring" shaped buildings. (F.Peja, B. Rraci, A. Hajdari: Castle of Harlilaq, 2012)

East of the basilica lay two identical ring shaped objects, as in size, shape and their construction technique. Their construction is in line with the basilica (See plan above fig.12). The dimensions of the structures are 18.40x11.50m and are oriented east with a slight deviation to the north. The interesting shapes of these structures consist of three spherical elements and a half spherical one. The apse space is the main bigger spherical part is connected with a rectangular part with an apse. This space is paved with lime mortar with river sand mixed with brick dust, insulated with hydro-plaster. The buildings communicate with each other through a staircase. In the middle of these two structures lies a fountain. The archeologists of the site suggest that the structures served as *martyriums*. The building technique places the structures on the same period

with the basilica and the fortress. The archeologist Gezim Hoxha suggest that these buildings might have served as *Mausoleums*.⁶ According to C. Haluk, the high position of monastic settlement and difficulty in obtaining water considered these structures as cistern.⁷

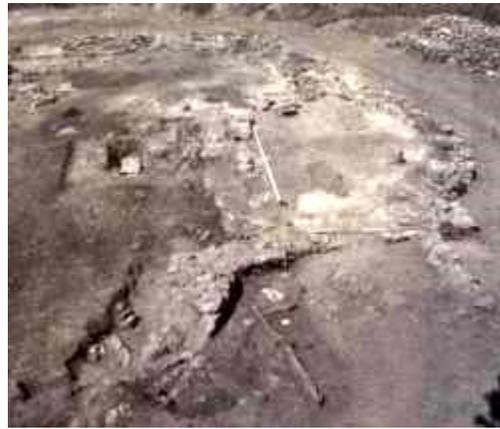
Figure 6. Early christian church of Kasterc (F. Peja, A. Hajdari, 2014)

After several decades, in 2010, the museum of Kosovo conducts another expedition with the lead of Fatmir Peja in several parts of the castle, where among the discoveries were a residential building (C), two lines of the fortification wall (A) and a sacral monument with a triconch shape (D).¹⁰

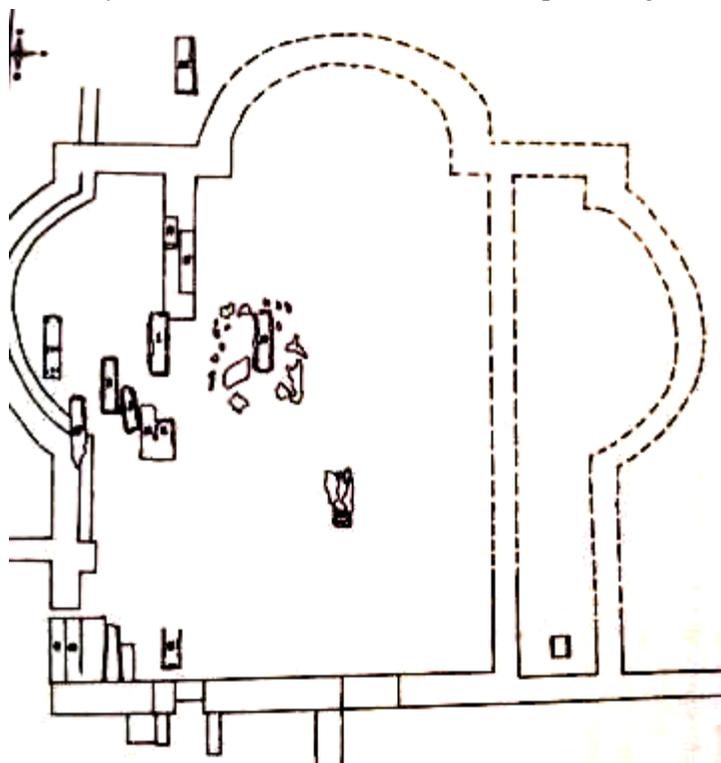
Figure 8. Plan of the church in Kasterc (F. Peja, A. Hajdari, 2014)

The three-aisled church with a shape of triconch is situated in the highest peak of the castle¹¹. Only the north and the west part of the church are excavated to this point. To this point, the west part of the building and the northern conch and a part of the eastern conch are revealed. A total of 19.5m of the building in length has been excavated.

The walls of the triconch are constructed of unhewn stones bonded with lime mortar. The walls of the building have a thickness of 1 meter. Three entrances that lead to the naos were discovered the first entrance from the south part with dimensions 1.70 m, the second one on the north part with dimensions 1.50m and the third entrance on the northwest corner with dimensions 2.30m.

The north wall of the building is supported by a flying buttress on each side, while the southern wall is supported by three flying buttresses that are not connected directly with the wall. There are evidences that the building has undergone several changes. There is a wall (between the northern wall and the northern conch) built on a later phase with a thickness of 30 cm, where gravels were used for mortar. Also, the northern entrance has been shrunk on a later phase, but as a bonding material, clay mortar was used.¹²

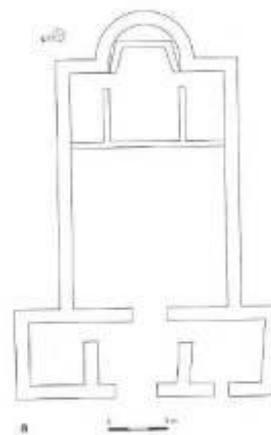
Figure 9. Plan of church of Korisha(AMP, 2006)

The basilica was revealed inside the fortification. The revealed basilica is 20,7 m long with a direction from east to west and is of single nave type. Its walls have a thickness of 0,70m. The basilica has a semicircular apse with a radius of 3,7m. The naos of the basilica has a rectangular shape and has dimension of 9,20 x 16 m. While the narthex is also rectangular and has dimensions of 4,70 x 13,40 m. The main entrance of the basilica is 1,85m long, and is constructed with a slight asymmetry in relation with the main façade. While the entrance from the narthex to the naos, is symmetrical with the naos (fig.1)¹⁸.

The narthex is divided into three parts, the main space and two small rooms in the north and south. The north room has dimension of 2,90 x 3,30 m and an entrance of 1 m connecting it with the narthex. The south room has dimensions of 3,60 x 3,30 m, and its entrance is mirrored like the north one. This room has also an opening to the main façade as a parallel entrance to the basilica. From the ground plan of the basilica asymmetries are visible, but for a building of this size.¹⁹

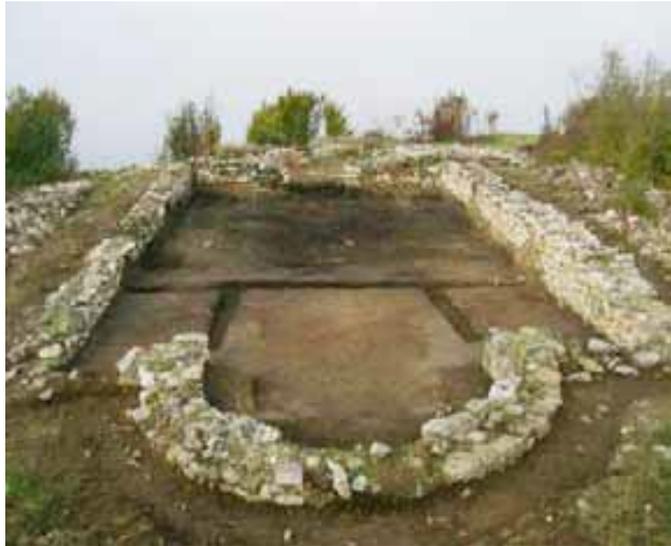
Figure 10. Early Christian basilica in Korisha (AGK, 2012)

The wall of the basilica seems to have been built simultaneously with a same style all around. It has a thickness of 0.70m. It consists of stone masonry bonded with lime mortar. Although, the lime is of low quality, the masons seem to have been very professional in applying the stones and the lime mortar in a very professional way. For the walls of the facades the stones were selected more carefully. There are also traces of plastering “*in-situ*”, on the parts of the altar with a thickness of 3-4cm²⁰. The lime mortar used for plastering has a little amount of sand. On the part of the apse, some parts of plastering appear with red color.

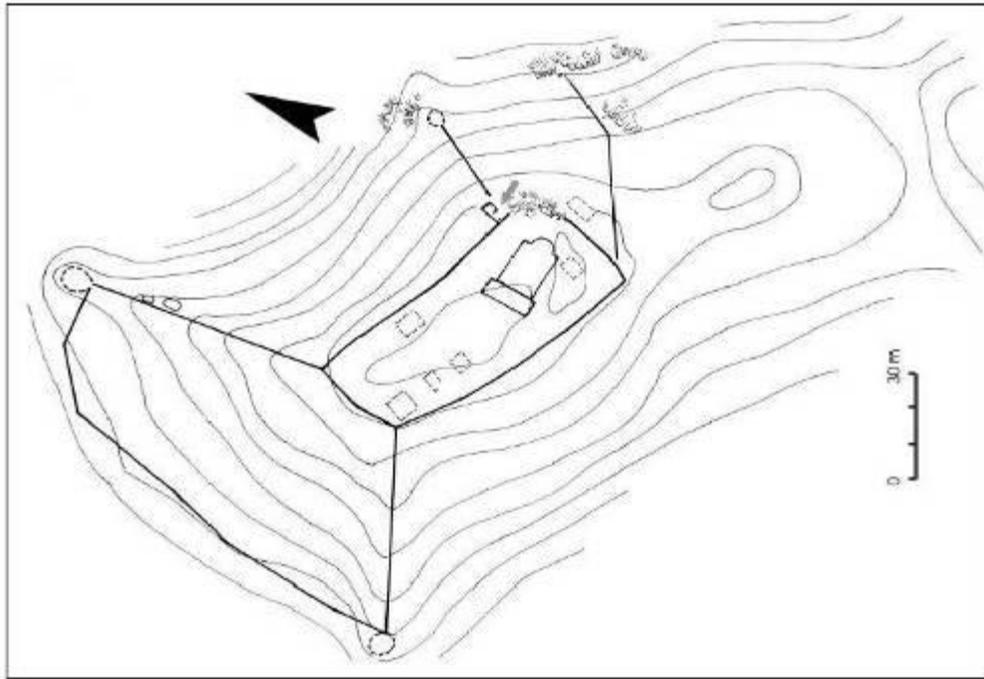
Figure 11. Korishas plan (AMK, 2006)

During excavations in the inner part of the apse, traces of the construction of the synthrone were noticed. The *synthron* has a trapezoidal shape, with the narrow base directed to the east. The *synthron* has a simple step of 22-25 cm above the floor of the church. Side legs, the north and south ones, are 1,76m long, while the east one is 2,5m long. On the main part of the synthron, there was no visible lime mortar, leading to the assumption that there used to be the wooden cathedra.

Another important discovery in this building is the appearance of the chancel (presbyterium). The traces of its foundations are visible on the floor of the church. The base of the presbyterium has a base of 0,30 cm. The current excavations have not revealed any architectural part of this structure. The unexcavated parts inside the church might bring light to this discovery. (Hoxha 2015)²²

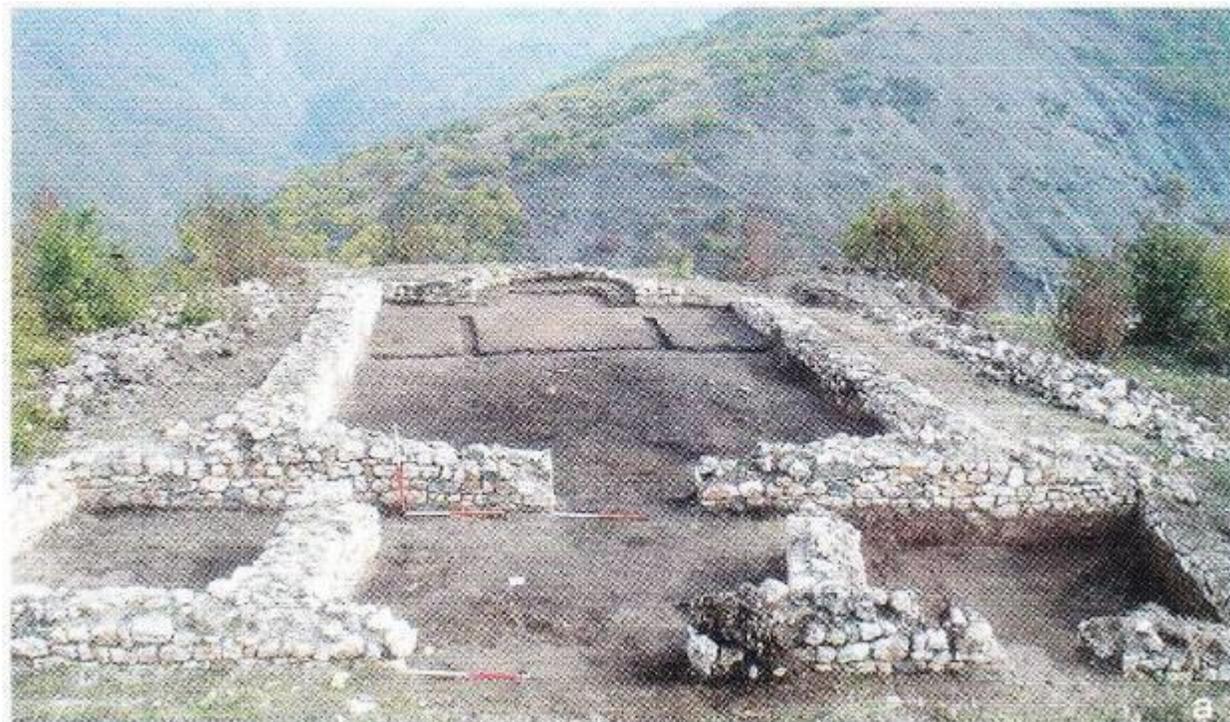
Figure 12. Korisha basilica (G.Hoxha, 2016)

Due to the findings on the spot, the church was dated in the 6th century. The finding of late medieval period ceramics in the proximity of the walls, led to the assumption that the building was abandoned in the pre-Turk period.²⁴
